**Flood Control Project Maintenance
Levee Inspections**

Maintenance Issue Types Only, Levee Inspection Report By Mile - Spring 2018

Reclamation District No. 2095 Paradise Cut

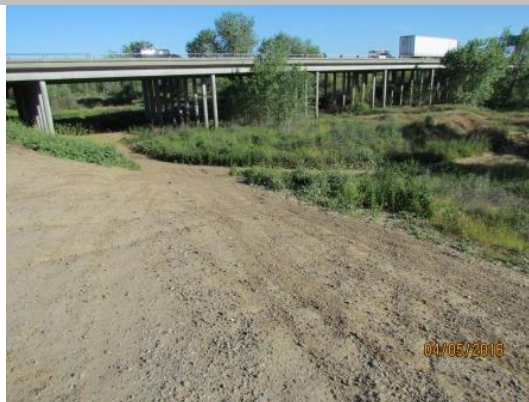
Photo 1 of 1 : SP_2018_RD2095_322_10_20180507_00001.jpg

LM Start	0.15	Rating **	A/W	Issue No.	10
LM End	0.15	Issue Type +	Ma	Location *	WS
Category	Earthen Levee			GPS Latitude/Longitude	
				Start	End
Item	Slope Stability			37.769997 °	37.769997 °
				-121.325055 °	-121.325055 °
DWR ID	DWR_RD2095_01_f_2015_10				
Comment Code					
S3 : Repair the levee slope damaged by vehicle traffic and prevent access where possible.					
Inspector Comment					
LMA is actively controlling access. The slope appears to be stable and should be monitored for possible erosion.

View of the vehicle tracks on the waterside levee slope.

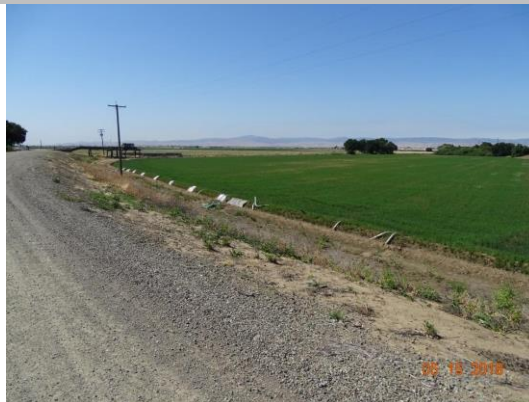
Photo 1 of 1 : SP_2018_RD2095_322_5_20180516_00015.jpg

LM Start	0.78	Rating **	A	Issue No.	5
LM End	1.47	Issue Type +	Ma	Location *	LS
Category	Earthen Levee			GPS Latitude/Longitude	
				Start	End
Item	Vegetation			37.762857 °	37.759172 °
				-121.318371 °	-121.308117 °
DWR ID	DWR_RD2095_01_s_2018_5				
Comment Code					
V1 : Control annual grass and weeds on the levee slopes and easements.					
Inspector Comment					
LMA is doing an excellent job maintaining their vegetation.

View of well-maintained landside slope. Spring 2018.

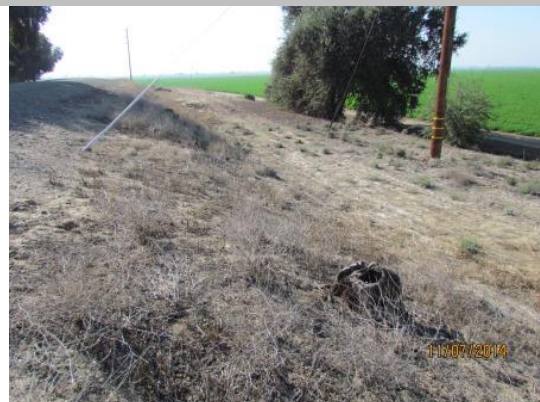
Photo 1 of 1 : SP_2018_RD2095_323_3_20180507_00005.jpg

LM Start	1.09	Rating **	N	Issue No.	3
LM End	1.09	Issue Type +	Ma	Location *	LS
Category	Earthen Levee			GPS Latitude/Longitude	
				Start	End
Item	Trim / Thin Trees			37.748184 °	37.748184 °
				-121.298995 °	-121.298995 °
DWR ID	DWR_RD2095_02_s _ 2012_3				
Comment Code					
T5 : Tree stumps.					
Inspector Comment					
4 stumps

View of the tree stumps on the landside levee slope..

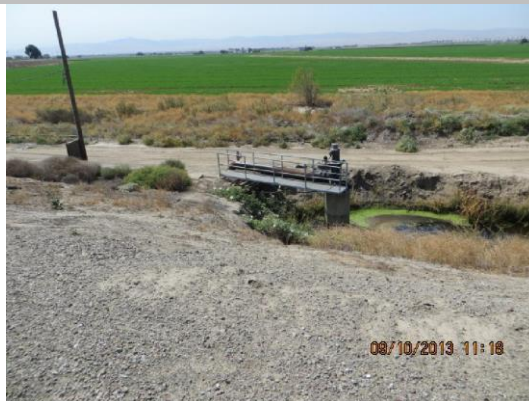
Photo 1 of 1 : UCIP_SP_2018_19863_33760.jpg

LM Start	1.48	Rating **	M	Issue No.	942
LM End	1.48	Issue Type +	Ma	Location *	
Category	Supplemental			GPS Latitude/Longitude	
				Start	End
Item	DWR UCIP LMA Responsibility			37.743142 °	37.743142 °
				-121.297692 °	-121.297692 °
DWR ID					
Comment Code					
Inspector Comment					
FS_ID:19863 DS_ID:21642 EP_NO: 4658 Repair Type: Non-Urgent Crossing Status: Found UCIP Comments: Pipe appears abandoned in place and re-routed to LM 1.652. Need to verify pipe was properly abandoned. Permit FIELD_STRUCT_DESC: *ABANDONED* 14-inch steel drainage pipe through the levee, 3.5 feet below the crown. Pump on structure over drainage ditch on the landside (LS). Flap gate on the waterside (WS) end. (Permit No. 4658, 1964 - Cochran Company, Inc.). [Additional Reference(s): DWR Levee Log, 2005. USACE San Joaquin O&M Manual 11, 1968, (HLM 1.51)]. FS Date: 9/10/2013

Pump visible on LS toe, but pipe has been re-routed to southwest.

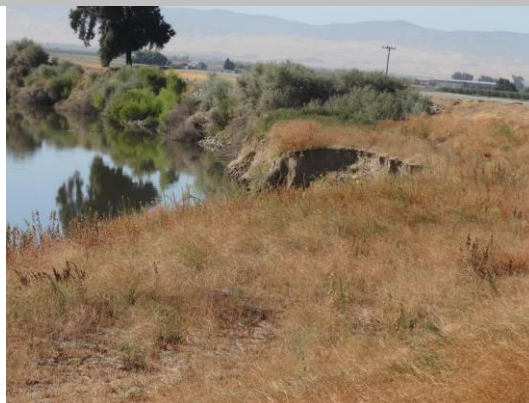
Photo 1 of 4 : SP_2018_RD2095_323_1_20180507_00001.jpg

10/04/2017: The erosion has further expanded toward the levee toe. The berm width has shortened to approximately 14 feet. The erosion also has further lengthened upstream. Vegetation has grown denser at the site.

07/20/2016: The erosion extended toward the levee toe. The berm width was reduced by approximately five (5) feet.

9/29/2009: Site is immediately downstream of a section of existing rip rap; there is a 20-foot berm remaining; berm will continue to erode unless erosion is mitigated; Site# is the same as RM62.6, LM1.87; recommended for annual assessment, per CES Evaluation 2008 Report 2006: Visited 10/20/06 [2017 Site ID:RD2095U02RM60.62]

Looking at the erosion from downstream.

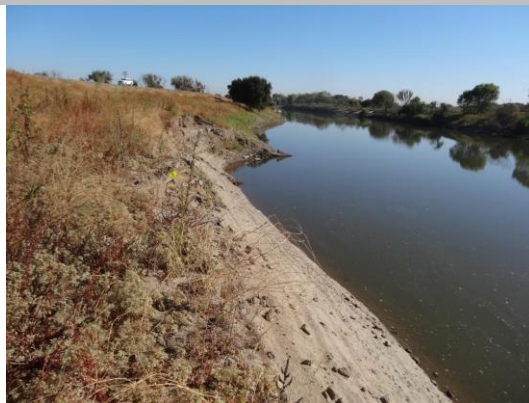
Photo 2 of 4 : SP_2018_RD2095_323_1_20180507_00002.jpg

Looking at the erosion from upstream.

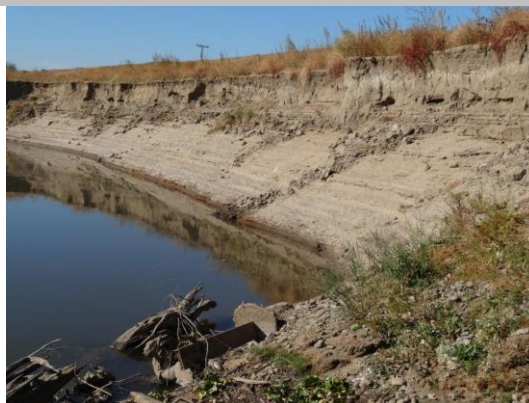
Photo 3 of 4 : SP_2018_RD2095_323_1_20180507_00003.jpg

10/04/2017: The erosion has further expanded toward the levee toe. The berm width has shortened to approximately 14 feet. The erosion also has further lengthened upstream. Vegetation has grown denser at the site.

07/20/2016: The erosion extended toward the levee toe. The berm width was reduced by approximately five (5) feet.

Close view of the erosion.

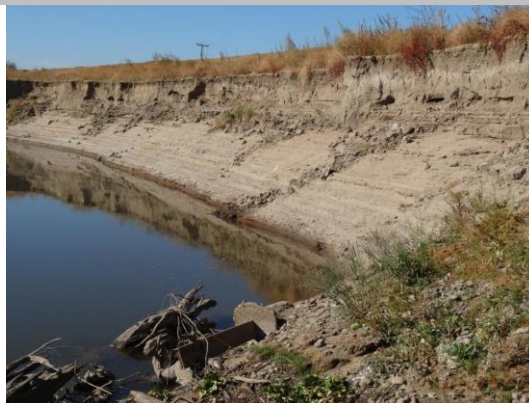
Photo 4 of 4 : SP_2018_RD2095_323_1_20180507_00004.jpg

Close view of the erosion.

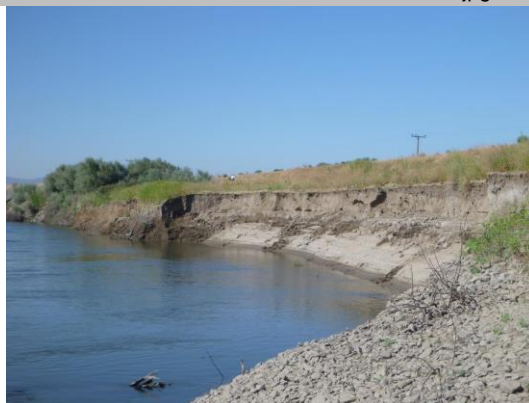
Photo 3 of 3 : LEVAL_SP_2018_469_2353.jpg

Comment Code					
Inspector Comment					
<p>Levee Evaluation Comments</p> <p>Description: Active waterside erosion on San Joaquin River near the end of Wright Road in Tracy, CA. Total length of erosion extends 615. Erosion has extended 15 feet towards levee toe this flood season. Please see attached map and photos. As the high water level recedes from the winter storm, we can see more damage to this site. Erosion is active.</p> <p>Site ID No: 469</p> <p>Site Designation: LMA-296</p> <p>Repair Type: Erosion</p> <p>Rating: Serious</p> <p>Field Date: 7/26/2017</p> <p>Notes: This is an active erosion site. Zero vegetation within the eroded portion. It may not be quite in the prism now, but lost about 20 ft (horizontally) of bank last year. Saw eddies in the water here also.</p>

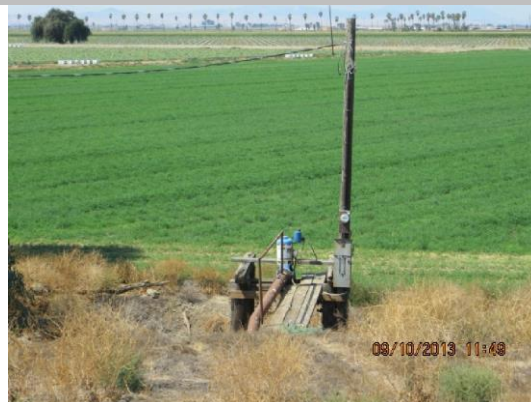
Photo 1 of 2 : UCIP_SP_2018_19871_33778.jpg

LM Start	2.38	Rating **	A/W	Issue No.	945
LM End	2.38	Issue Type +	Ma	Location *	
Category	Supplemental			GPS Latitude/Longitude	
				Start	End
Item	DWR UCIP LMA Responsibility			37.731313 °	37.731313 °
				-121.298298 °	-121.298298 °
DWR ID					
Comment Code					
Inspector Comment					
FS_ID:19871 DS_ID:21644 EP_NO: N/A Repair Type: No Action Needed Crossing Status: Found UCIP Comments: FIELD_STRUCT_DESC: 8-inch steel drainage pipe through the levee, 3 feet below the crown. Pump in drainage ditch on the landside (LS). Vent pipe at the waterside (WS) toe. 1.5-inch galvanized iron electrical conduit through the levee at the same location. Service pole with a switch box and meter on the LS. [Additional Reference(s): DWR Levee Log, 2005. USACE San Joaquin O&M Manual 11, 1968, (HLM 2.41)]. FS Date: 9/10/2013

Pump on metal pier off LS toe.

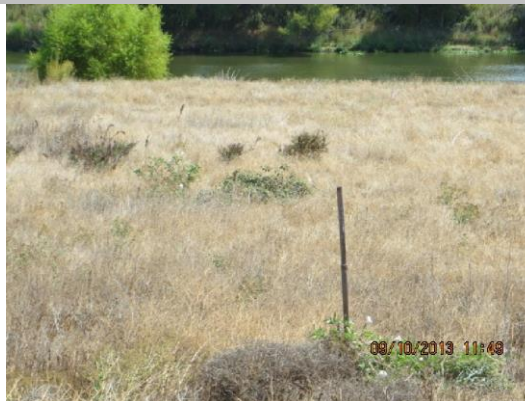
Photo 2 of 2 : UCIP_SP_2018_19871_33777.jpg

LM Start	2.38	Rating **	A/W	Issue No.	945 (cont)	
LM End	2.38	Issue Type +	Ma	Location *		
Category	Supplemental			GPS Latitude/Longitude		
				Start		End
Item	DWR UCIP LMA Responsibility			37.731313 °		37.731313 °
				-121.298298 °		-121.298298 °
DWR ID						
Comment Code						
Inspector Comment						
FS_ID:19871 DS_ID:21644 EP_NO: N/A Repair Type: No Action Needed Crossing Status: Found UCIP Comments: FIELD_STRUCT_DESC: 8-inch steel drainage pipe through the levee, 3 feet below the crown. Pump in drainage ditch on the landside (LS). Vent pipe at the waterside (WS) toe. 1.5-inch galvanized iron electrical conduit through the levee at the same location. Service pole with a switch box and meter on the LS. [Additional Reference(s): DWR Levee Log, 2005. USACE San Joaquin O&M Manual 11, 1968, (HLM 2.41)]. FS Date: 9/10/2013

Vent standpipe on WS toe.
